# Measurement and verification of a lighting load reduction project through energy efficiency

## Abstract

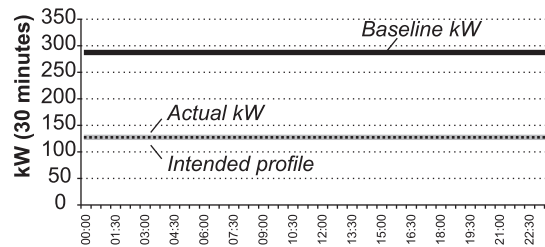
The contracted impact was 157 kW and, at the end of the project, the actual impact was 156 kW. Therefore, the project was under-performing by 0.64% of its intended target. This was an acceptable underperformance figure. This impact is shown in Figure 3.

**Figure 3: Average weekday demand profile**

The average weekday demand profile was the same as the average Saturday and Sunday demand profile as the mine is operational for 24 hours daily. Since the operation of the mine is constant the impact is applicable to any time period.

The baseline determined that the installed capacity of the lighting system was 287.6kW. The post implementation assessment determined that the new lighting system's installed capacity was 131.3kW. The lights are operational for 24 hours with no breakage, and therefore, the impact of the lighting retrofit is about 156kW. This is 0.64% lower than the contracted target for this project.
